Solar PV Cleaning Report

Client: Clean Earth Energy Ltd
Site name: Slough Court
Address: Stoke St Gregory, Somerset
Helios Project Manager: Robert Harley
Date of Clean: 5th, 15th & 16th June 2020

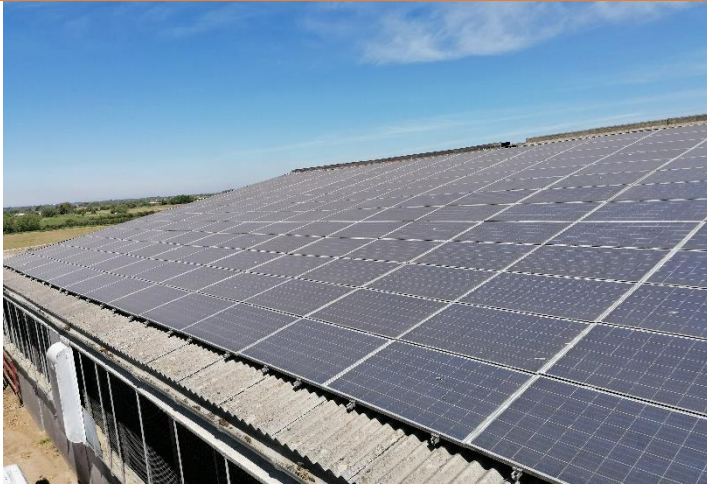
First roof prior to
cleaning

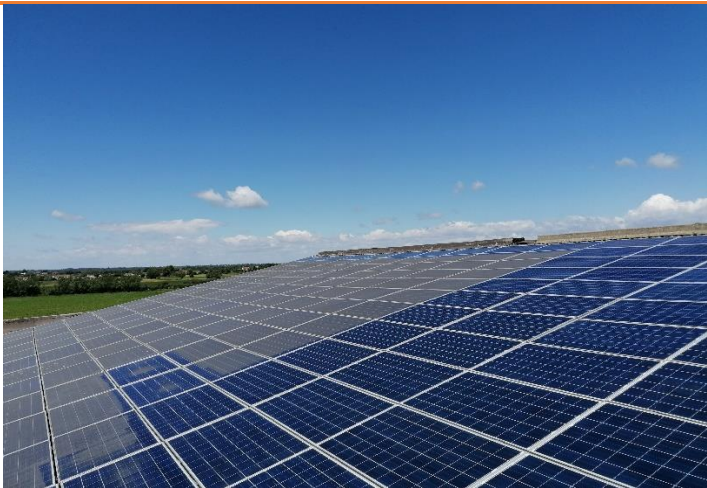
First roof during cleaning

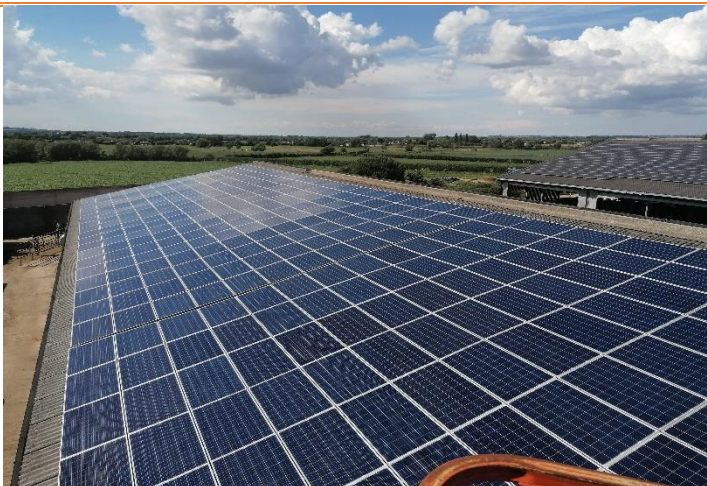
First roof completed

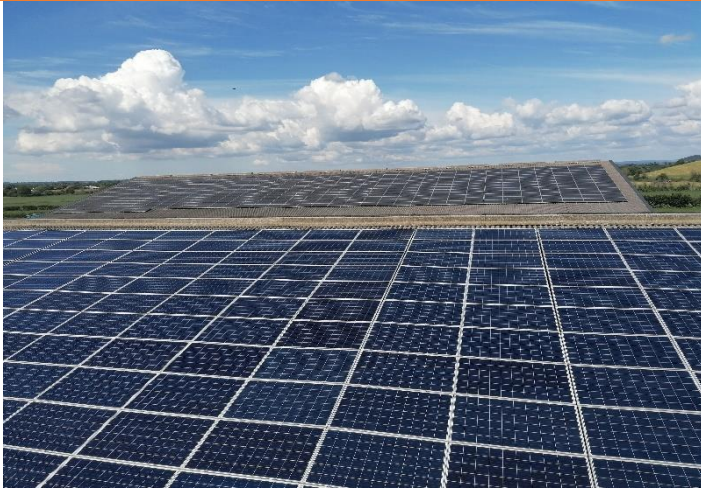
Contrast between
cleaned array and dirty
array behind

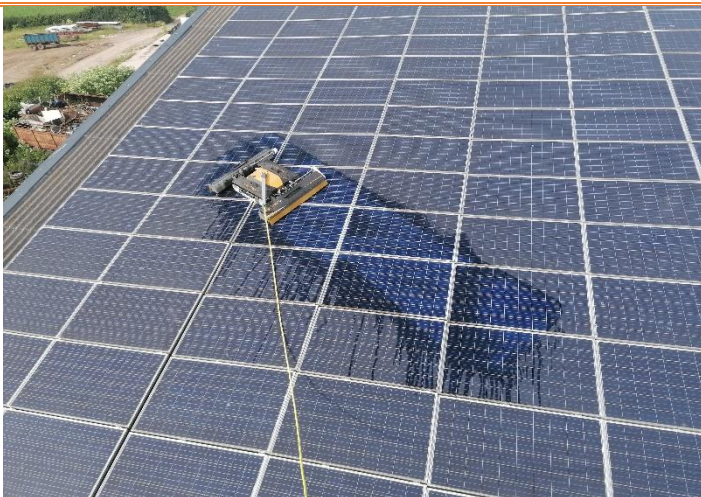
Robot after 4 passes

It is doubtful that the same level of cleaning could be achieved with anything other than a robot. This is because every panel needed at least 8 passes of the robot to bring it up to a satisfactory condition. Some panels, despite having in excess of 12 passes of the robot with the stiffest brushes available, still could not be cleaned perfectly. These were predominantly on the most upper and lower rows of panels.

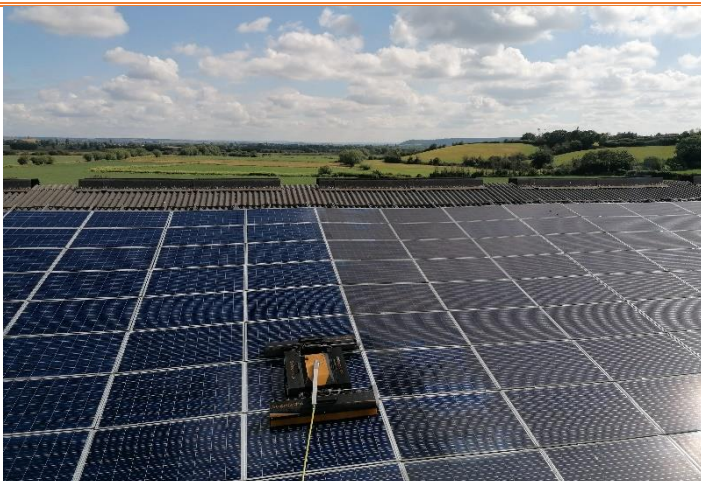
Contrast between clean
and dirty panels on
second array.

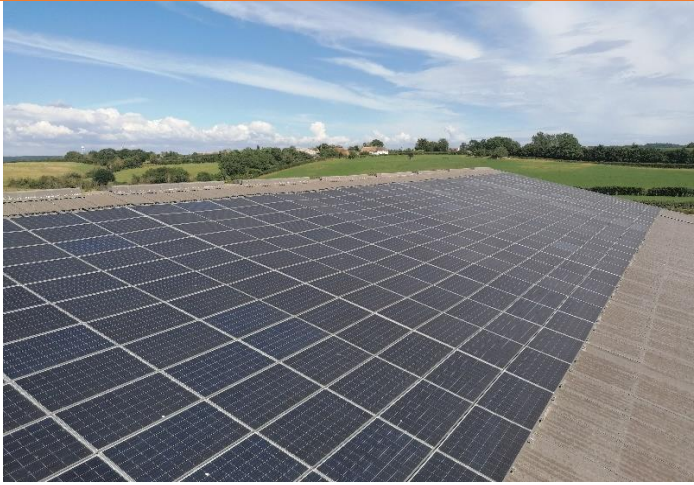
Second roof prior to
cleaning

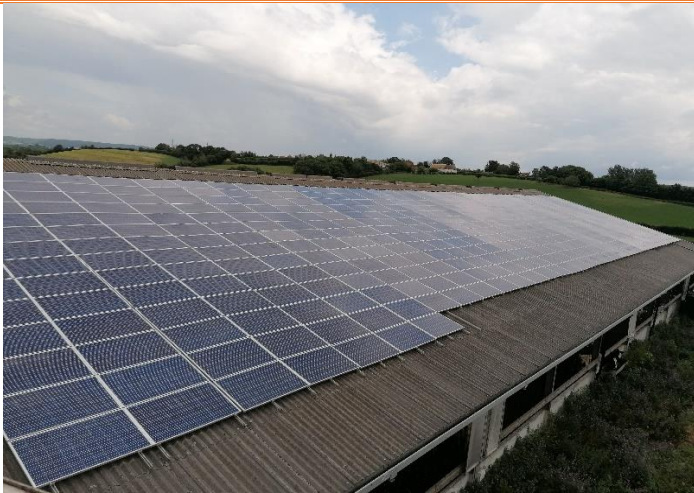
Second roof after
cleaning

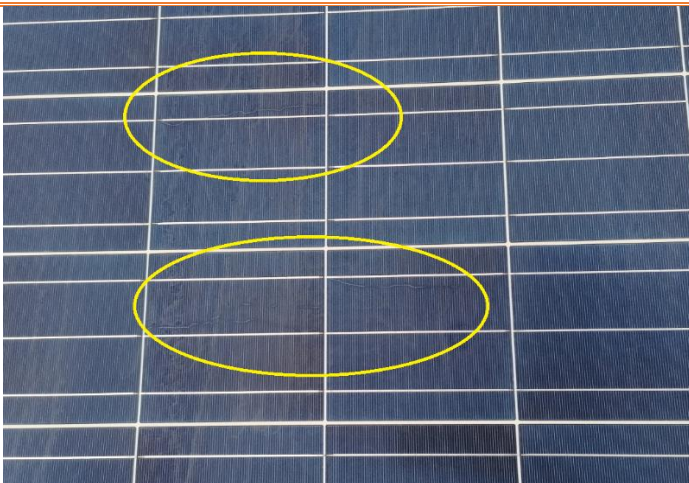
"Snail Trails" on panels.
May require further
investigation
